Manhole Inspection Summary

Manhole # S21GG_031MH

Insp Date: **6/15/07 11:09 AM**

Location Address: **1607 FULTON AVE**

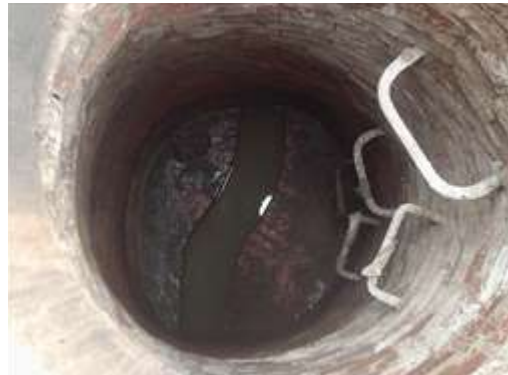
Top View

Comments **MANHOLE IS BACKING UP AND FLOWING IN THE REVERSE DIRECTION, CHANNEL HAS AN "S" SHAPE TO IT.**

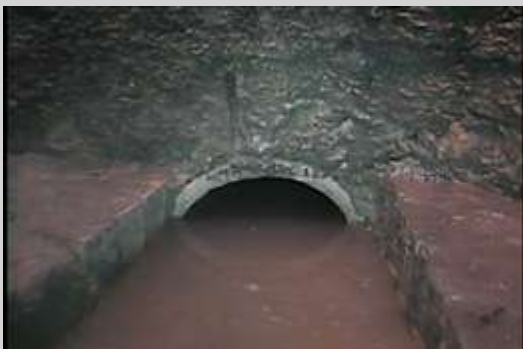
6 O'Clock Inflow

8 in. Circular Gravity Sewer
Pipe In @ 6 O'Clock

Pipe Height: **8.4** (in.) Rod and Bar (Angled)
Pipe Material: **Clay** ☐ Pipe Lined
Invert Depth: **9.82** (ft.) Flow Characteristics: **Slow**
Deposits: ☒ None ☐ Mud ☐ Sludge ☐ Debris ☐ Grease
Silt Depth: (in.) Deposits Extent:
Infiltration: **None** Pipe Seal Cond: **Sound**
